DRAFT REPORT

VIRGIN RIVER RESTORATION

An evaluation of alternatives with focus on the potential
to regenerate cottonwood (*Populus fremontii*) along the
North Fork of the Virgin River in Zion National Park

April 2001

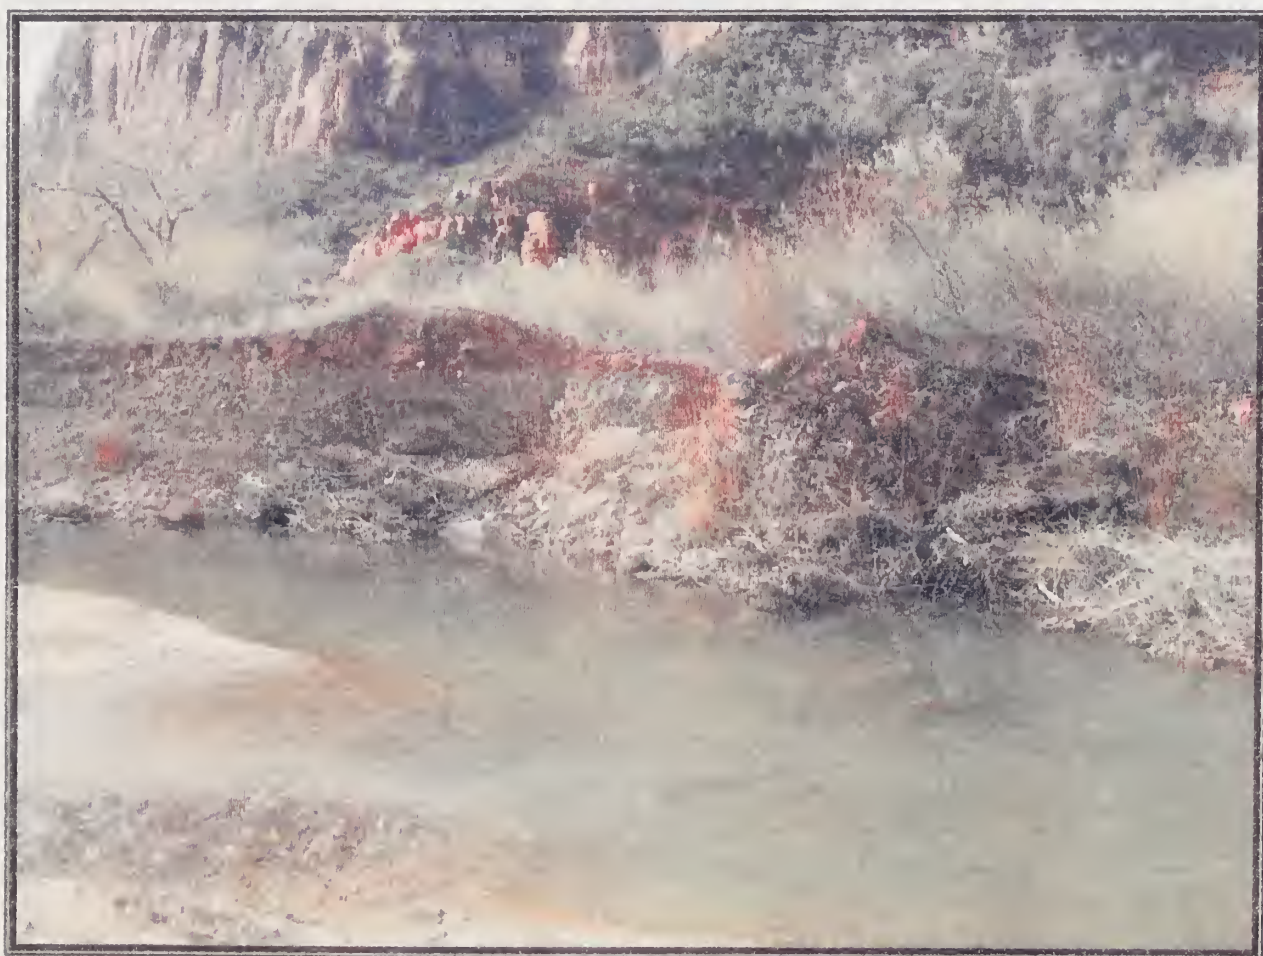
Much of the revetment is in surprisingly good condition considering it was constructed 60 – 70 years ago. However in many places the wire has rusted away and become a safety hazard. In the area near Emerald Pools the river has breached the revetments on both sides of the river and created a sharp meander. In other places the wire has given way and the rock is dropping out the bottom of the basket and into the river. For a more details see Appendix 3.

FIGURE 15. Rock revetments in disrepair near Zion Lodge
